EVEKTOR - AEROTECHNIK Inc.

MANDATORY BULLETIN No.: SPORTSTAR – 017 a SR
SAFETY ALERT

1. **CONCERNING:** All **SportStar** aeroplanes registered in Ultra-light (Advanced Ultra-light) or Light Sport category.
2. **REASON:** It was found an increased rudder deflection during investigation of aircraft accident of SportStar RTC, OK-EAK, S/N 20111402, which happened during spin testing.
The rudder deflection change could be caused due to a movement of a Nicopress clamp on the rudder cables under repeated rudder pedal full deflections up to the stops during spins.
It is therefore mandated an inspection of Nicopress clamps pressing as well as Inspection of rudder deflections on all aeroplanes made by Evektor-Aerotechnik, which use similar system of directional control.

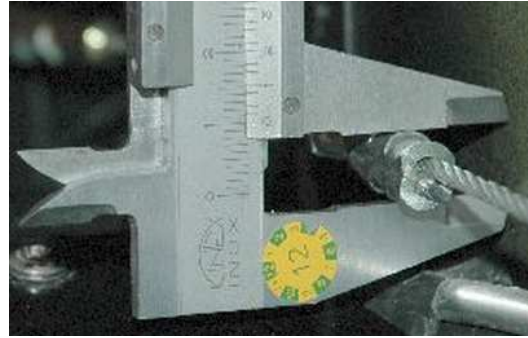
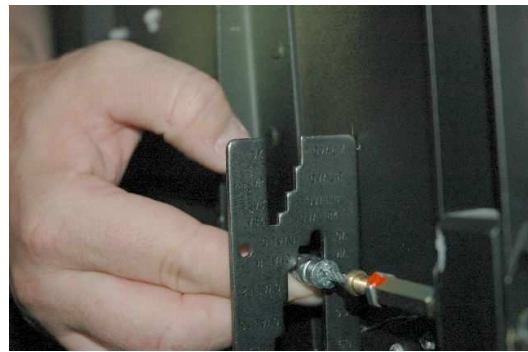
5. Use a Vernier calliper to measure width of each Nicopress clamp as shown on the pictures.

Clamp width to be measured as shown on the picture on the right i.e. over the larger diameter (one cable above another between calliper jaws).

Clamp width must be less or equal to 9 mm (0.35 in).

The gauge should be possible to slip over the clamp up to OVAL M cut out. If not, then such clamp was not properly pressed.

7. If the width of any of the clamps is higher than 9 mm (0.35 in) then such clamp was not sufficiently pressed and strength of the directional control stops is probably reduced.

Report this fact to the aeroplane manufacturer
(see contact data in this Bulletin).

Take corrective actions according to Appendix 3.

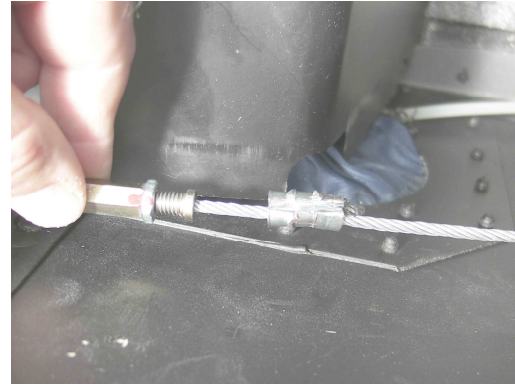
3. Try to slide each adjustable screw along the cable.

4. If it is impossible to slide the screws along the cables on your aircraft, then they were already stuck by the aeroplane manufacturer thus it is not necessary to stick them. Proceed with Inspection of the rudder deflections according to the Appendix 4 and Inspection of Adjustment of Directional Control Stops according to the Appendix 5.

5. If the screws may be slid along the cables, then they need to be stuck.

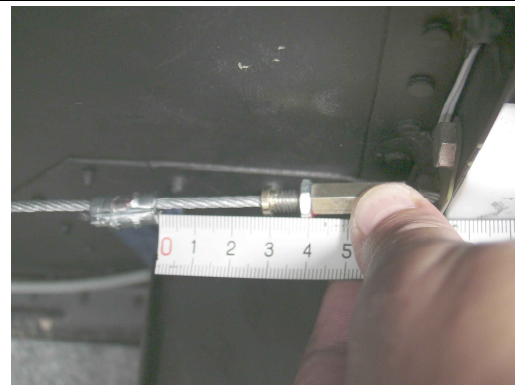
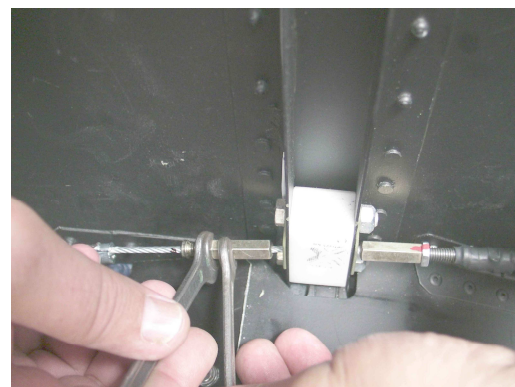
It is recommended to measure rudder deflections according to Appendix 4 before sticking the screws. If the rudder deflections would be too high (35° to 40°) and the adjustable screws would be stuck at the Nicopress clamp, then it may happen, that the screws would be not long enough to allow rudder deflections adjustment into the permitted range. So in case of rudder high deflections it is necessary to stick the screws in some distance from the Nicopress clamps.

6. Try if it is possible to slide a screw off the Nicopress clamp of approx 30 mm (1.2 in) to uncover cable. If impossible, then release counter nut using metric nut wrenches size 8 and 10 and screw the inner bolt into outer hexagonal nut that far, so that approximately 28 to 30 mm (1.1 to 1.2 in) of cable is uncovered between the Nicopress clamp and adjustable screw when the crew is slid off the Nicopress clamp.

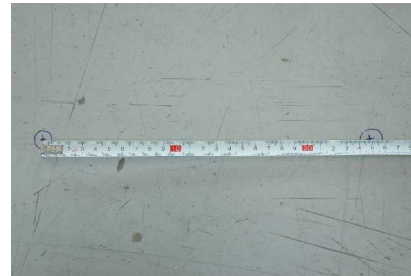
17. Refer to the table to find rudder right and left deflection in degrees corresponding to by you measured distances.
 Note: Accuracy of measurement is within 0.5 deg. (2-3 mm).

18. Check, whether found deflections lie within permitted range $30 \pm 2^\circ$ (i.e. 28° to 32°).
 If YES, then rudder deflections comply.
 Proceed in accordance with Appendix 5 A/ Inspection of Adjustment of Adjustable Stop Screws.
 If NO, then rudder deflections do not comply.
Report this fact to the aeroplane manufacturer (see contact data in this Bulletin). Proceed with Appendix 5 B/ Rudder Deflections Adjustment.

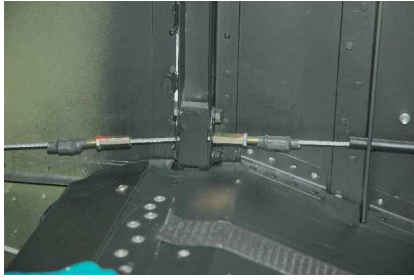
3.	Push the co-pilot's right pedal fully forward and observe, whether at the same moment reaches the right rear adjustable screw the stop on the starboard side and left front adjustable screw the stop on the port side. If not, then it is advisable to use metric nut wrenches size 8 and 10 to adjust the screws so that both screws reach the stops simultaneously. Note: The picture shows right rear adjustable screw when reached the stop. Simultaneously the left front screw should reach its stop.

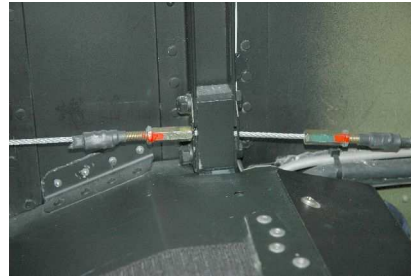
4. Push the pilot's left pedal fully forward and observe, whether at the same moment reaches the left rear adjustable screw the stop on the port side and right front adjustable screw the stop on the starboard side. If not, then it is advisable to use metric nut wrenches size 8 and 10 to adjust the screws so that both screws reach the stops simultaneously.

Note: The picture shows left rear adjustable screw when reached the stop. Simultaneously the right front screw should reach its stop.

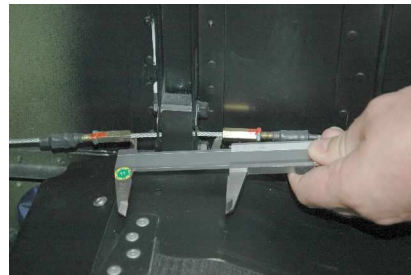
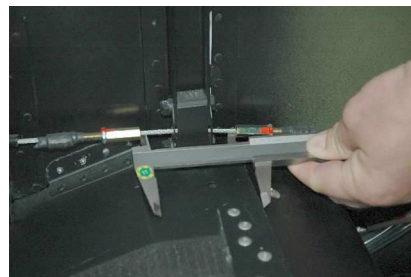
5. Use a Vernier calliper to measure distance between faces of the adjustable stop screws, both on the port and then starboard side. The distances should not differ more than 2-3 mm (0.08 to 0.12 mm). Adjust the screws if this range is exceeded, the distances should be approximately equal.
