**MANDATORY BULLETIN No. EV 97 – 016 a
SPORTSTAR – 015 a**

1. **CONCERNING TO:** Only the **EV-97 Eurostar** and **SportStar** airplanes **fitted with an autopilot**.
2. **REASON:** During a pre-flight inspection of a SportStar having an autopilot installation, jamming of the lateral control moved fully to the right was found. The cause was a failure of a zip tie attaching the fabric boot to the rods which allowed the compressing of the fabric boot covering aileron servo rod and aileron rod at the fuselage right side. Compressed fabric boot in combination with a small clearance between the right upholstery panel and aileron servo rod caused jamming of the lateral control – see Appendix 1.

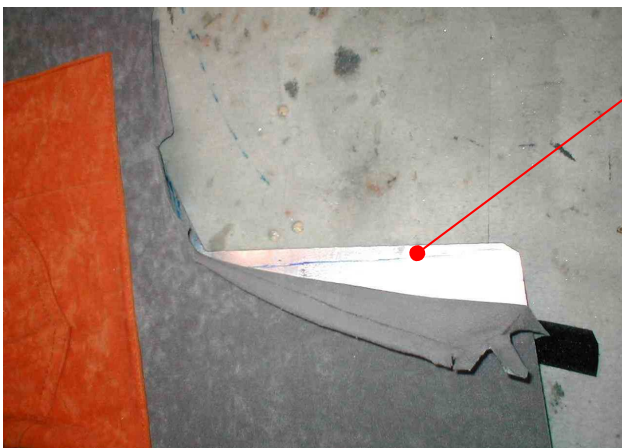
Front edge.
Enlarge the cut
out.

2. Remove right seat upholstery. Remove hand control right cover in front of the right seat. Visually check clearance between the front rod and edge of the upholstery panel. If the clearance is less than 10-12 mm i.e. ½" (see picture on previous page), then carefully remove right upholstery panel (its top edge is inserted under the fuselage side angle and further Velcro strips are used to fix panel to the fuselage side), carefully remove the upholstery in area of the cut out (see picture below), use pencil and rule to mark new shape of cut out, trim by means of snips, deburr, glue upholstery back to panel.

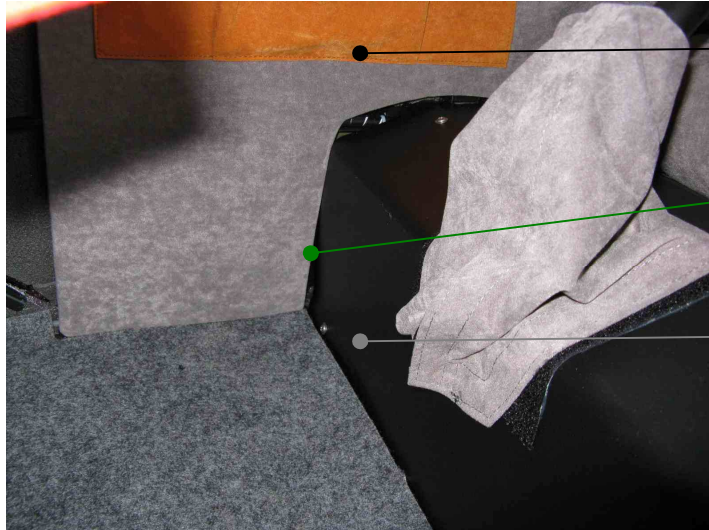
Front edge.
Cut out trimmed.

Re-install the upholstery panel. Re-install the hand control right cover.

Move a control stick left and right to check lateral control full movement.
