EVEKTOR - AEROTECHNIK Inc.

MANDATORY BULLETIN No.: SPORTSTAR – 017 a SR
SAFETY ALERT

1. **CONCERNING:** All **SportStar** aeroplanes registered in Ultra-light (Advanced Ultra-light) or Light Sport category.
2. **REASON:** It was found an increased rudder deflection during investigation of aircraft accident of SportStar RTC, OK-EAK, S/N 20111402, which happened during spin testing.
The rudder deflection change could be caused due to a movement of a Nicopress clamp on the rudder cables under repeated rudder pedal full deflections up to the stops during spins.
It is therefore mandated an inspection of Nicopress clamps pressing as well as Inspection of rudder deflections on all aeroplanes made by Evektor-Aerotechnik, which use similar system of directional control.

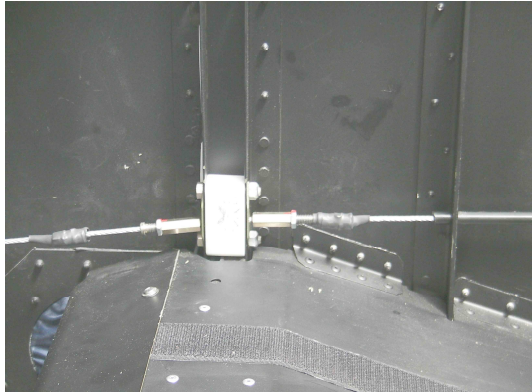
<p>Tooling:</p> <ul style="list-style-type: none"><input type="checkbox"/> Loctite 648<input type="checkbox"/> Nut wrenches metric size 8 and 10, to release adjustable stop screws<input type="checkbox"/> Degreasing agent to degrease control cables (e.g. industrial spirit, Teroson FL, etc.)<input type="checkbox"/> A piece of suitable fabric to apply decreasing agent and clean the cables	
	<p>Procedure:</p> <p>1 person needed. Duration approx. 1 ½ hour.</p>	
1.	<p>Seat upholstery and padded panels removed from the cockpit.</p>

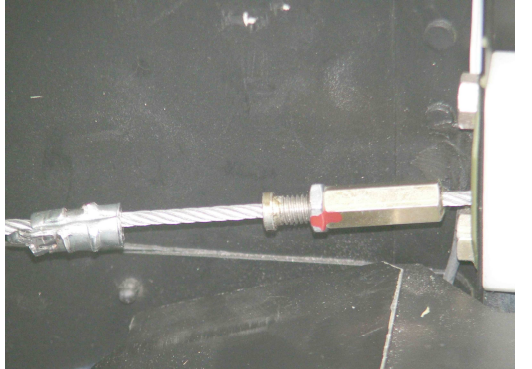
2.	<p>Shrinking hoses removed from the Nicopress clamps.</p>

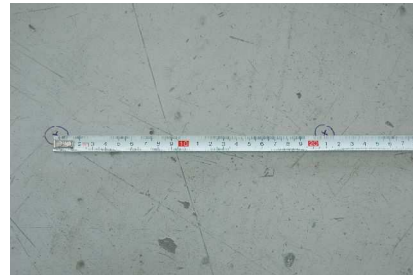
18. Check, whether found deflections lie within permitted range $30 \pm 2^\circ$ (i.e. 28° to 32°).
 If YES, then rudder deflections comply.
 Proceed in accordance with Appendix 5 A/ Inspection of Adjustment of Adjustable Stop Screws.
 If NO, then rudder deflections do not comply.
Report this fact to the aeroplane manufacturer (see contact data in this Bulletin). Proceed with Appendix 5 B/ Rudder Deflections Adjustment.

16. Use a tape rule or ruler placed on the floor (which should be flat) to measure distances between neutral position and right deflection and neutral position and left deflection.
